VENDORS DISCLOSURE STATEMENT

LOT 1 ON BUP 104043
BAINES VIEW CTS 16217
123 BAINES STREET
KANGAROO POINT QLD 4169

123 Baines Street, Kangaroo Point Qld 4169

Scheme Number: 16217

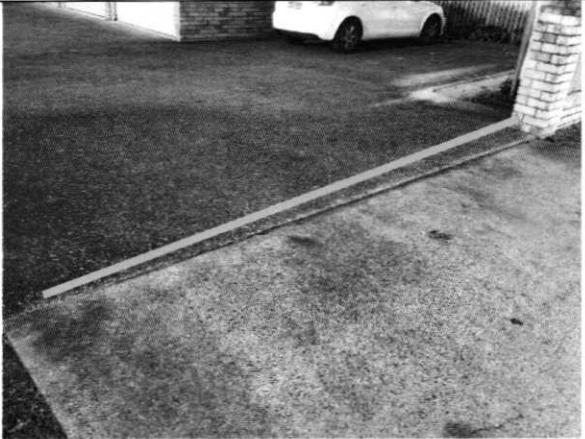
Surface Variation	No	Moderate

<p>Item 1: Please ensure that the upper edge of the lip/s in the driveway area at front boundary are ground back at approx. 25 degrees as soon as possible as they currently represent a moderate tripping hazard.</p>
Surface Contamination	Yes		No hazards apparent at time of inspection. The driveway surfaces showed no signs of hazardous deterioration or contamination.
Obstructions	Yes		No hazards apparent. Vegetation is well trimmed and driveways were not obstructed.

Please ensure that the upper edge of the lip/s in the driveway area at front boundary are ground back at approx. 25 degrees as soon as possible as they currently represent a moderate tripping hazard.

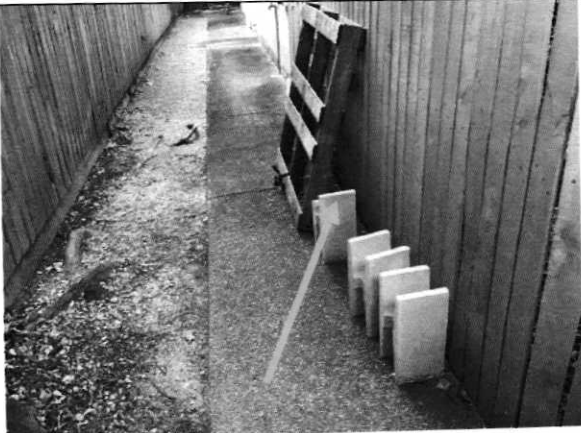
Pathway Surface Contamination Levels	Yes		No hazards apparent at time of inspection. No hazardous contamination was evident at the time of inspection.
Access/Egress	No	Moderate

<p>Item 3: Please remove the items obstructing the external pathways Left-hand side path as soon as possible as they currently represent a moderate hazard.</p>

Please remove the items obstructing the external pathways Left-hand side path as soon as possible as they currently represent a moderate hazard.

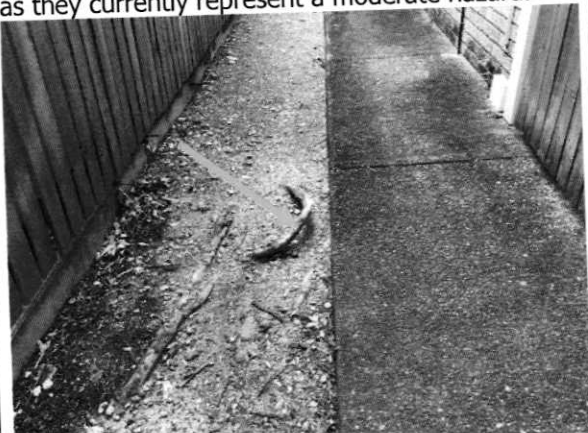
<p>Item 4: Please trim the vegetation encroaching upon the pathway Exposed tree root on Left-hand side of building as soon as possible as it currently represents a moderate impact hazard.</p>
External Path/Stair Light Fittings	Yes		No hazards apparent at time of inspection. The external common property accessway light fittings were intact and unobstructed.

Please trim the vegetation encroaching upon the pathway Exposed tree root on Left-hand side of building as soon as possible as it currently represents a moderate impact hazard.
